AGENDA

Fiscal Affairs Committee

Green Valley Recreation, Inc.
1655 South Abrego Drive | Green Valley, Arizona

GREEN VALLEY RECREATION CENTER DISTRESS EVALUATION
GREEN VALLEY, ARIZONA

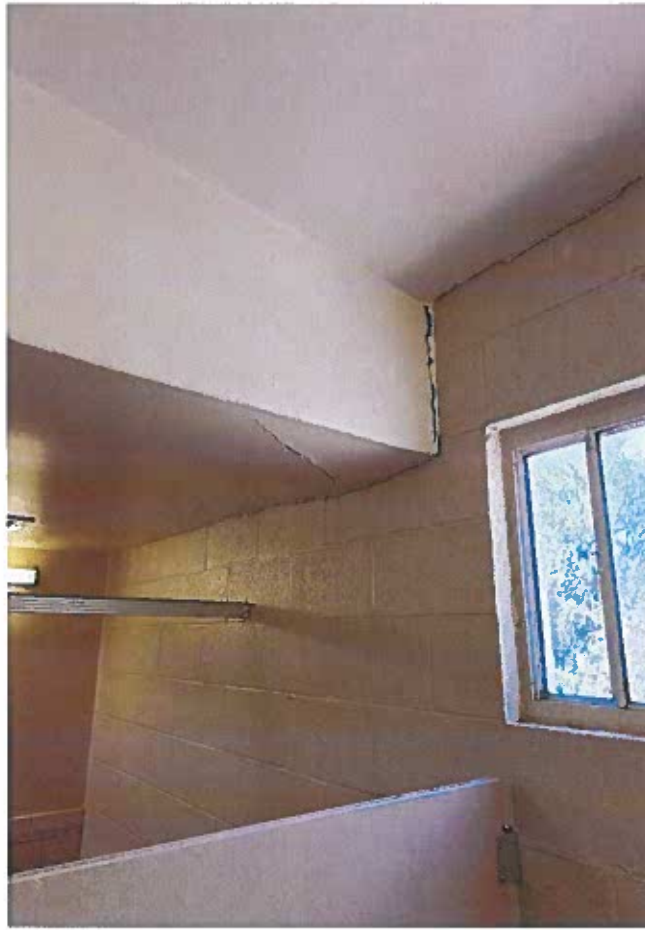
FIGURE C-1

Photograph 1: Bath House - Ceiling and Wall Separation

Typical measures to mitigate the building distress similar to what have been reported at this building include underpinning of the building and the perimeter wall foundations (footings and slabs on grade) to provide additional support and the reduce potential for future movements. This would include system of helical piers or micro-piles that are commonly designed and installed by specialty contractors. For the design of such mitigation measures, additional geotechnical services including deeper borings will need to be considered.

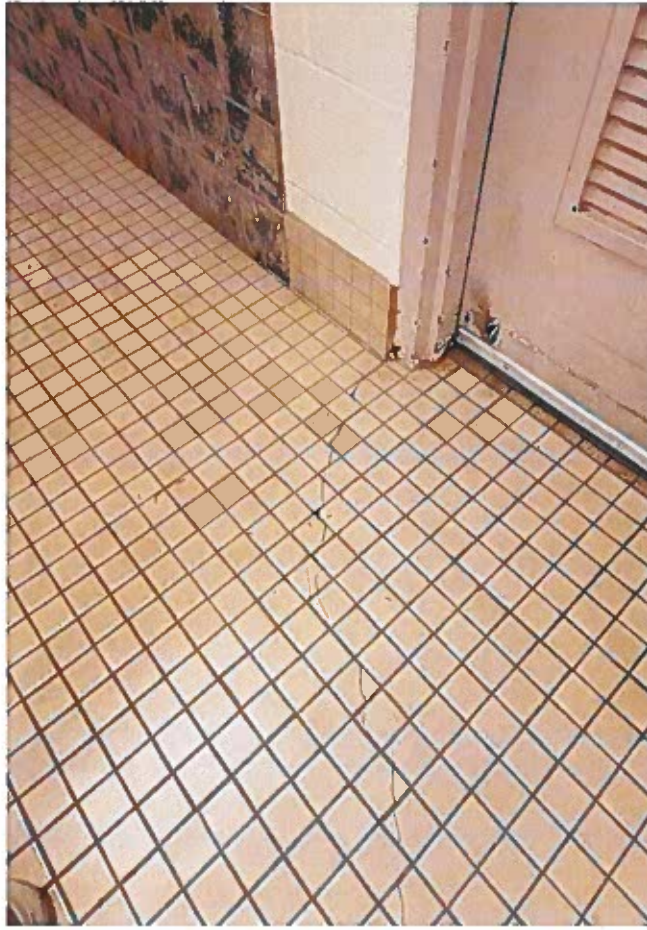
FIGURE C-3

Photograph 3: Bath House - Floor Tile Crack

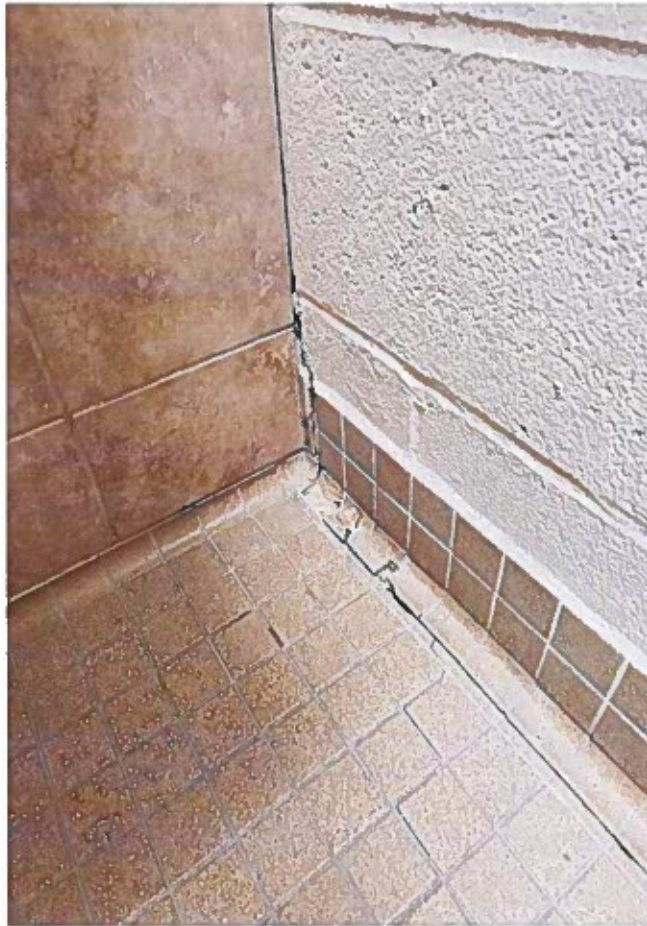
FIGURE C-4

Photograph 4: **Bath House - Floor Tile Damage**

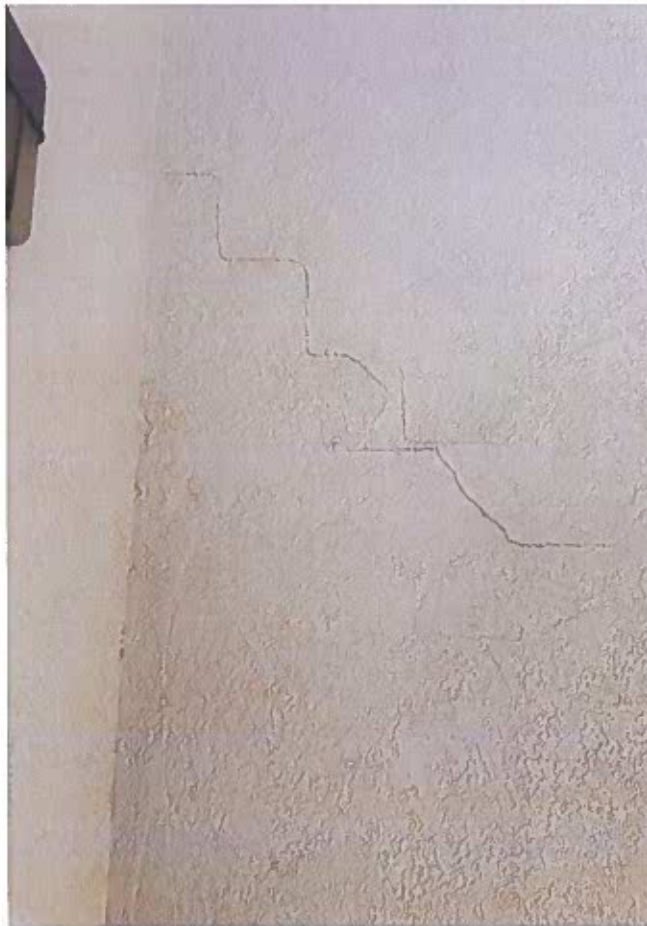
FIGURE C-5

Photograph 5: Bath House - Stepping Crack in Exterior Wall

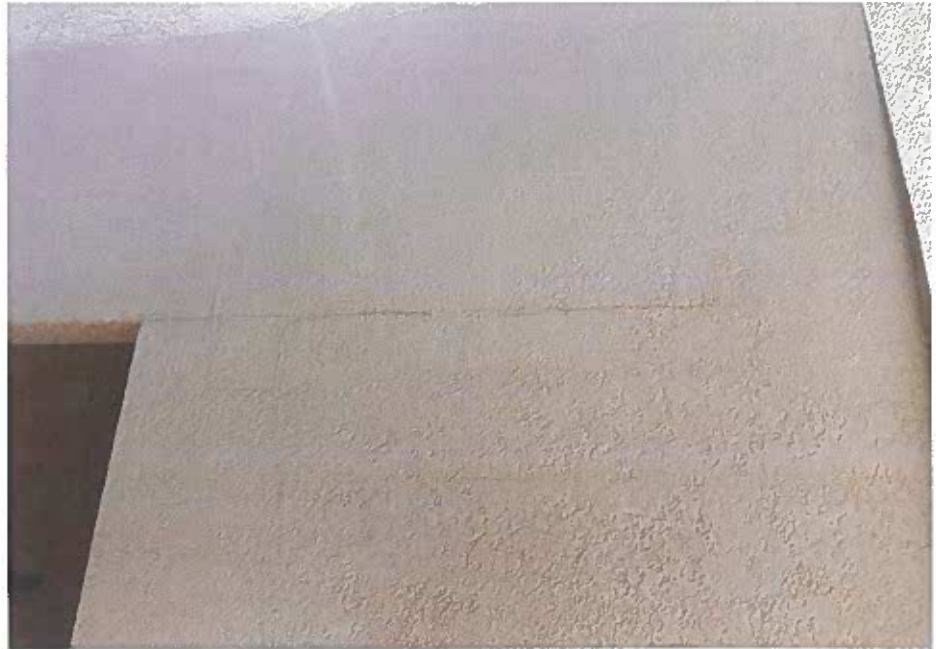
FIGURE C-6

Photograph 6: **Bath House - Horizontal Crack in Exterior Wall**

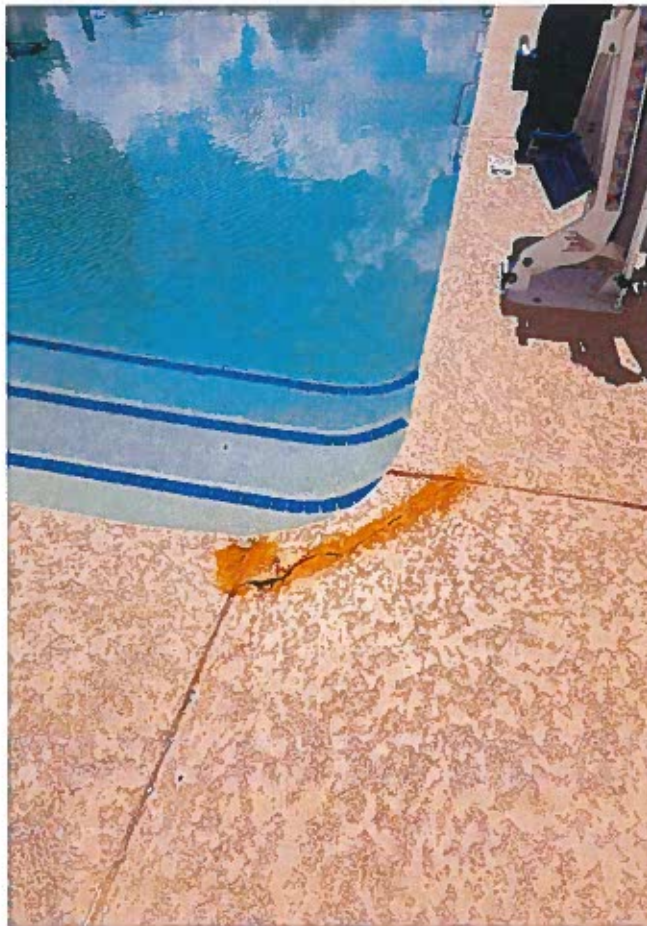
FIGURE C-7

Photograph 7: Concrete Deck - Corner Crack

Possible mitigation of the concrete deck slab movements should include overexcavation of the subgrade soils to depths indicating competent soil strata, which may be below the depths of our exploration (7.5 feet bgs) and replacement of the excavated soils with compacted engineered fill placed in 6-inch-thick lifts at a moisture content generally close to the optimum.

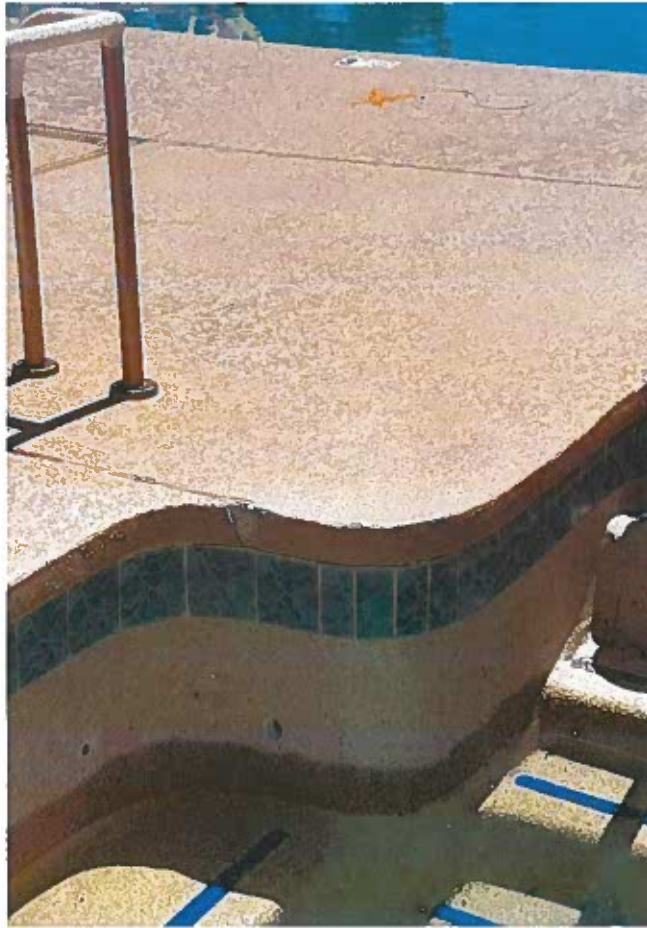
FIGURE C-11

Photograph 11: **Spa - Deck Separation**

The pool distress, although believed to be largely associated with the above discussed subsurface conditions, should be subject of additional evaluation of the fill soils condition under its bottom.

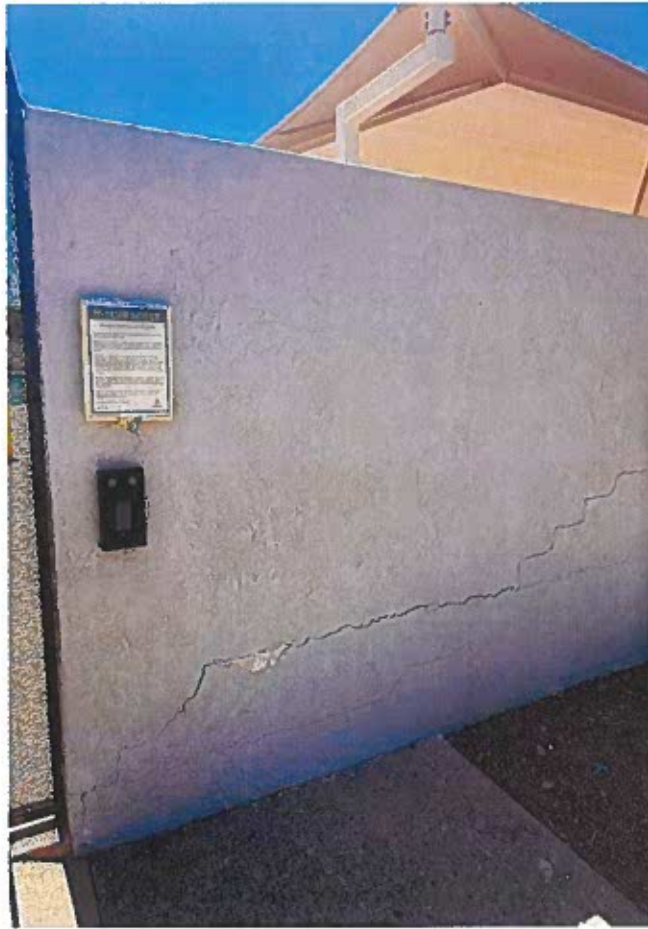
FIGURE C-12

- Pool and spa:
 - Vertical cracks and separations in the pool walls;
 - Cracks in the pool bottom slab; and
 - Cracks and separations in spa walls.
- The equipment area perimeter wall exhibited horizontal and stepping cracks.

Photograph 12: Equipment Area - Horizontal Crack in Masonry Wall
