MEMO

TO: Scott Somers, CEO
FROM: David Webster, CFO
DATE: February 23, 2026
RE: Maintenance Repair & Replacement Fund for Pools & Spas (MRR-B)

Pool and Spa Facilities Update

Summary of Aqua Design International (ADI) Facility Evaluations

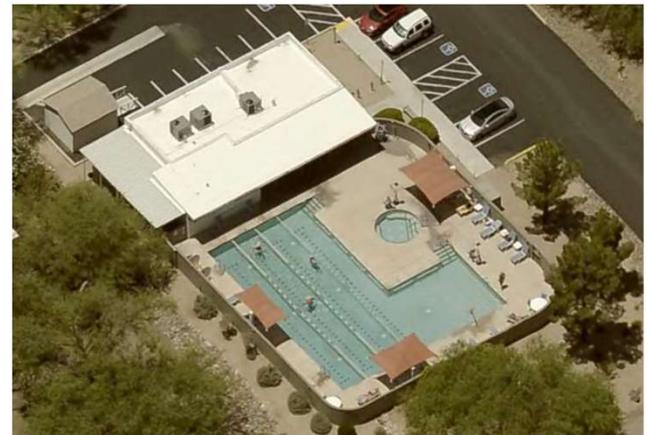
Abrego North

Pool built 1978/*rebuilt 2016*, 30x60 ft, 57,370 gallons

- Replace two chemical controllers to digital systems for accuracy
- Replace backwash valves that are better/less restrictive
- Install three D2 power vents on Raypak gas heaters to prevent sooting
- Install vacuum gauge on suction side of spa pump
- Pool Deck: do scratch-coat, add acrylic lace topping and paint

- Install new chemical placards per code. Replace life rings with new 24" size.
- Remove minor scale build-up on pools, spa, rails, tiles. Use 3M pad or media blast
- Balance chemicals to reduce copper staining from heaters
- Clean pool deck with TSP and pressure washer to remove staining

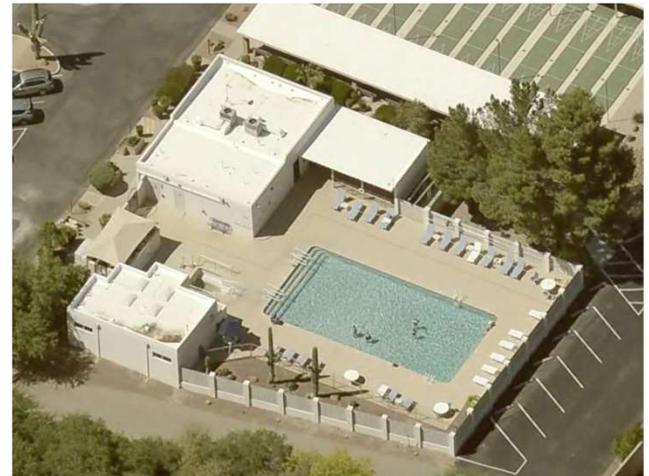
Abrego South

Pool built 1977, 30x60 ft, 44,112 gallons

- Replace two chemical controllers to digital systems for accuracy
- Re-install lift at spa. Currently on the ground.
- Install additional TR-140 filter to pool. Replace spa filter with new TR-140 for correct flow
- Replace 3hp single-speed pool pumps with 2 new 3hp variable-speed pumps or one 5hp pump
- Replace 3hp spa pump with new 3hp variable-speed pump
- Replace backwash valves that are less restrictive. Re-plumb equipment room for efficiency.
- Install three D2 power vents on Raypak gas heaters to prevent sooting
- Install Flo-viz meters and vacuum gauges on suction side of pumps per code.
- Install Emergency Shut-off (ESO) switch by pool and spa to meet current code
- Install Pentair I10D automated control system with an Intellichem control system

- Install new chemical placards per code. Replace life rings with new 24" size.
- Remove minor scale build-up on pools, spa, rails, tiles. Use 3M pad or media blast
- Balance chemicals to reduce copper staining from heaters
- Clean pool deck with TSP and pressure washer to remove staining
- Clean spa jet orifices. If done right, may eliminate need for jet pump.
- Ensure pool drains are VGB compliant. Must have labels. Replace every 3 to 5 years.

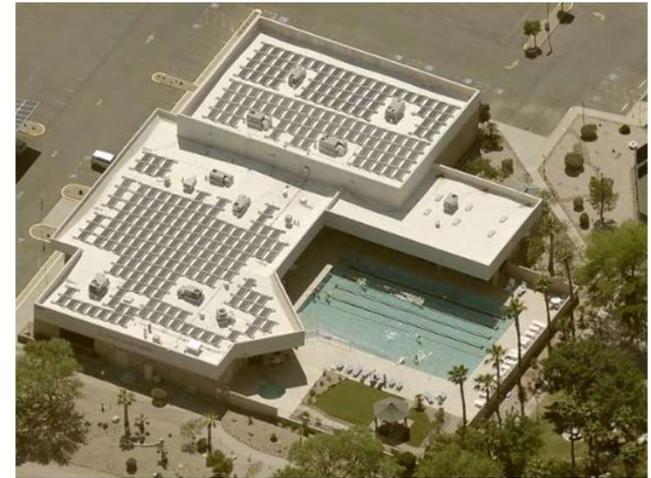
Canoa Hills

❑ **Pool built 1990, 55x82 ft, 125,033 gallons**

- ❑ Replace two chemical controllers to digital systems for accuracy
- ❑ Check pool lights for proper securement.
- ❑ U-3 style skimmers: repair weirs and install correct baskets

- ❑ Install additional TR-140 filter to pool. Replace spa filter with new TR-140 for correct flow.
- ❑ Replace three 3hp single-speed pool pumps with two new 5hp variable-speed pumps. Electrical issue.

- ❑ Replace pipes on pool heater power vents to meet code. Should be SS sealed pipe: Dura-vent or Z-Vent.
- ❑ Install one D2 power vents on Raypak gas heater for spa to prevent sooting

- ❑ Replace 3hp single-speed spa pump with new 3hp variable-speed pump
- ❑ Replace backwash valves that are less restrictive. Re-plumb equipment room for efficiency.

- ❑ Install Flo-viz meters and vacuum gauges on suction side of pumps per code.
- ❑ Install Emergency Shut-off (ESO) switch by pool and spa to meet current code

- ❑ Install Pentair I10D automated control system with an Intellichem control system

- ❑ Install new chemical placards per code. Replace life rings with new 24" size.
- ❑ Remove minor scale build-up on pools, spa, rails, tiles. Use 3M pad or media blast
- ❑ Balance chemicals to reduce copper staining from heaters
- ❑ Clean pool deck with TSP and pressure washer to remove staining
- ❑ Clean spa jet orifices. If done right, may eliminate need for jet pump.
- ❑ Ensure pool drains are VGB compliant. Must have labels. Replace every 3 to 5 years.

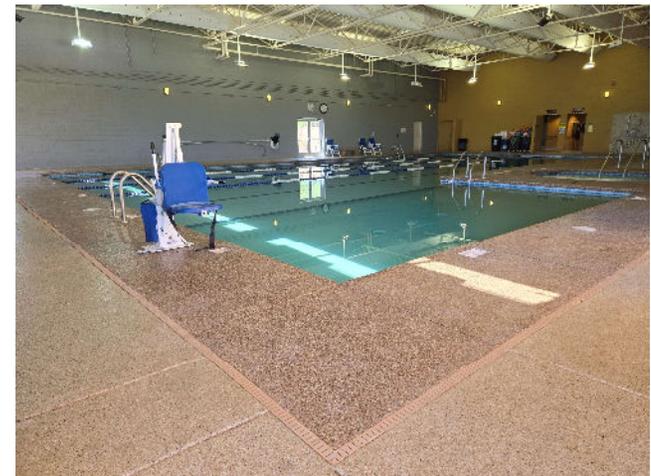
Canoa Ranch

Pool built 2007, 34x75 ft, 103,000 gallons

- Install correct vacuum fitting on side wall
- Replace two chemical controllers to digital systems for accuracy
- Replace three 3hp single-speed pool pumps with two 5hp variable-speed pumps or 3 3hp VS.
- Install two D2 power vents on Raypak gas heater for pool to prevent sooting
- Replace 3hp single-speed spa pump with new 3hp variable-speed pump
- Install one D2 power vent on Raypak gas heater for spa to prevent sooting
- Replace backwash valves that are less restrictive. Re-plumb equipment room.
- Install Flo-viz meters and vacuum gauges on suction side of pumps per code.
- Install Emergency Shut-off (ESO) switch by pool and spa to meet current code
- Install Pentair I10D automated control system with an Intellichem control system
- Install shade structure to protect value equipment from sun damage

- Install new chemical placards per code. Replace life rings with new 24" size.
- Remove minor scale build-up on pools, spa, rails, tiles. Use 3M pad or media blast
- Balance chemicals to reduce copper staining from heaters
- Ensure pool drains are VGB compliant. Must have labels. Replace every 3 to 5 years.

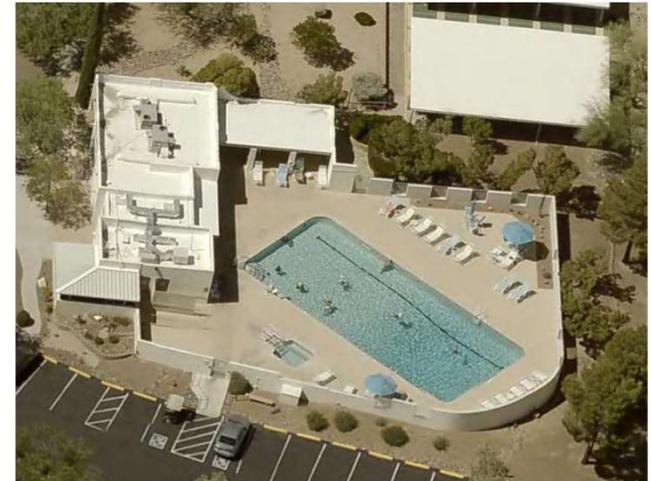
Casa Paloma I

❑ Pool built 1975, 32x70 ft, 86,010 gallons

- ❑ Replace two chemical controllers to digital systems for accuracy
- ❑ Replace worn depth tiles at waterline
- ❑ Replace filters with three TR-140 filters to pool. Add extra TR-100 filter to spa.
- ❑ Replace two 3hp single-speed pool pumps with two 5hp XF pumps.
- ❑ Install three D2 power vents on three Raypak gas heater for pool and spa to prevent sooting
- ❑ Replace 3hp single-speed spa pump with new 5hp variable-speed pump
- ❑ Replace backwash valves that are less restrictive. Re-plumb equipment room for efficiency.
- ❑ Install Flo-viz meters and vacuum gauges on suction side of pumps per code.
- ❑ Install Emergency Shut-off (ESO) switch by pool and spa to meet current code
- ❑ Relocate air blower to equipment room. Air flow enclosure does not allow enough air flow for blower.
- ❑ Remove air blower enclosure and landscape garden to meet code. Remove ability to climb over wall.

- ❑ Install new chemical placards per code. Replace life rings with new 24" size.
- ❑ Remove minor scale build-up on pools, spa, rails, tiles. Use 3M pad or media blast
- ❑ Balance chemicals to reduce copper staining from heaters
- ❑ Clean pool deck with TSP and pressure washer to remove staining. Repaint with acrylic paint.
- ❑ Clean spa jet orifices. If done right, may eliminate need for jet pump.
- ❑ Ensure pool drains are VGB compliant. Must have labels. Replace every 3 to 5 years.

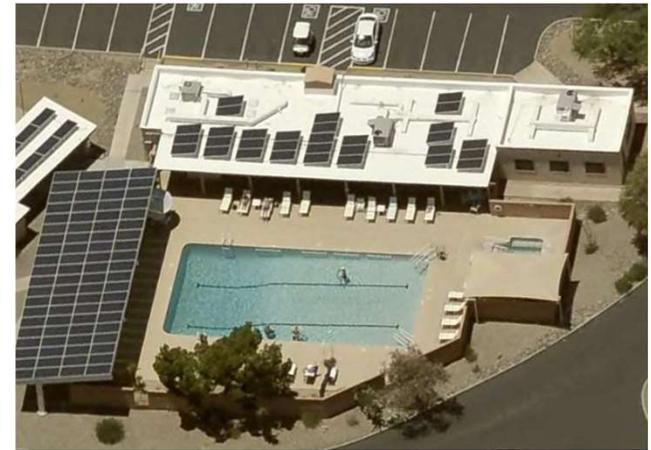
Casa Paloma II

❑ **Pool built 1977, 30x60 ft, 68,217 gallons**

- ❑ Replace two chemical controllers to digital systems for accuracy
- ❑ Readjust lights in pool and spa to ensure they are installed correctly
- ❑ Replace two pool filters with two TR-140 filters. Replace spa filter with TR-100 or TR-140 filter.
- ❑ Replace two 3hp single-speed pool pumps with two 3hp Intelliflow3 pumps.
- ❑ Install three D2 power vents on three Raypak gas heaters for pool and spa to prevent sooting
- ❑ Replace 1hp single-speed spa pump with 3hp variable-speed pump
- ❑ Replace backwash valves that are less restrictive. Re-plumb equipment room for efficiency.
- ❑ Install Flo-viz meters and vacuum gauges on suction side of pumps per code.
- ❑ Install Emergency Shut-off (ESO) switch by pool and spa to meet current code

- ❑ Install new chemical placards per code. Replace life rings with new 24" size.
- ❑ Remove minor scale build-up on pools, spa, rails, tiles. Use 3M pad or media blast
- ❑ Balance chemicals to reduce copper staining from heaters
- ❑ Ensure pool drains are VGB compliant. Must have labels. Replace every 3 to 5 years.

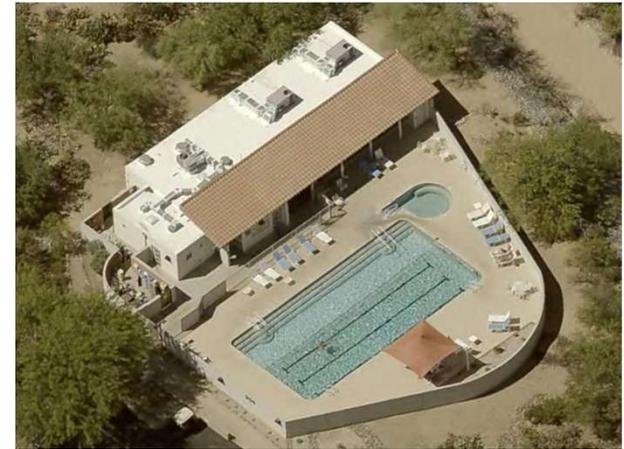
Continental Vistas

Pool built 1979, 30x60 ft, 67,329 gallons

- Replace two chemical controllers to digital systems for accuracy
- Replace two pool filters with two TR-140 filters. Replace spa filter with TR-140 filter.
- Replace two 3hp single-speed pool pumps with two 3hp Intelliflow3 pumps.
- Install three D2 power vents on three Raypak gas heaters for pool and spa to prevent sooting
- Replace one 3hp Whisperflow spa pump with 3hp Intelliflow variable-speed pump
- Replace backwash valves that are less restrictive. Re-plumb equipment room for efficiency.
- Install Flo-viz meters and vacuum gauges on suction side of pumps per code.
- Install Emergency Shut-off (ESO) switch by pool ad spa to meet current code
- Install Pentair I10D automated control system with an Intellichem control system
- Install shade structure to protect value equipment from sun damage

- Install new chemical placards per code. Replace life rings with new 24" size.
- Remove minor scale build-up on pools, spa, rails, tiles. Use 3M pad or media blast
- Clean pool deck with TSP and pressure washer to remove staining. Repaint with acrylic.
- Balance chemicals to reduce copper staining from heaters
- Ensure pool drains are VGB compliant. Must have labels. Replace every 3 to 5 years.

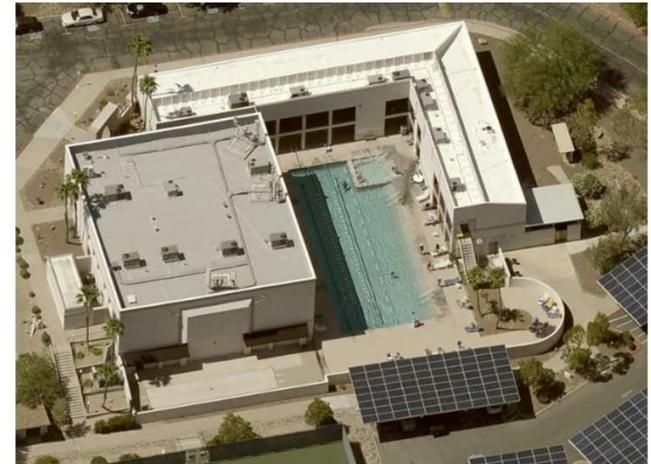
Desert Hills

❑ **Pool built 1981, 39x90 ft, 118,409 gallons**

- ❑ Replace two chemical controllers to digital systems for accuracy
- ❑ U-3 style skimmers: repair weirs and install correct baskets
- ❑ Replace three pool filters with three TR-140 filters. Replace spa filter with new TR-140 for correct flow.
- ❑ Replace three 3hp single-speed pool pumps with two new 5hp variable-speed pumps.
- ❑ Install D2 power vents on four Raypak gas heaters to prevent sooting. Replumb heater manifold.
- ❑ Replace backwash valves that are less restrictive. Re-plumb equipment room for efficiency.
- ❑ Install Flo-viz meters and vacuum gauges on suction side of pumps per code.
- ❑ Install Emergency Shut-off (ESO) switch by pool and spa to meet current code
- ❑ **Fix all plumbing in poor condition. Identify abandoned pipes. Replumb for proper flow.**

- ❑ Install new chemical placards per code. Replace life rings with new 24" size.
- ❑ Remove minor scale build-up on pools, spa, rails, tiles. Use 3M pad or media blast
- ❑ Clean pool deck with TSP and pressure washer to remove staining. Paint with acrylic
- ❑ Balance chemicals to reduce copper staining from heaters
- ❑ Replace pump seals. Showing signs of leaking.
- ❑ Ensure pool drains are VGB compliant. Must have labels. Replace every 3 to 5 years.

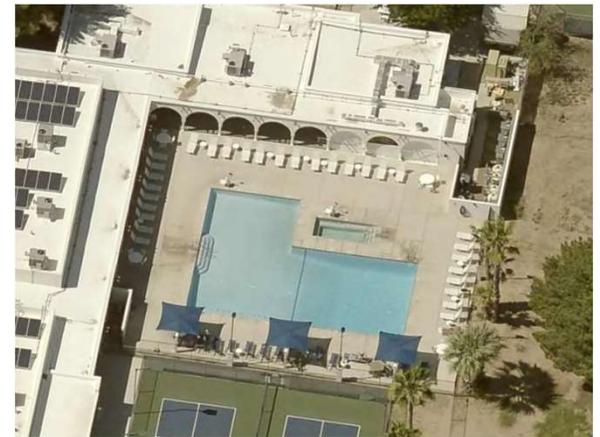
East Center

❑ Pool built 1963/*rebuilt 2023*, 25x60 ft, 75,000 gallons

❑ Install shade structure to protect value equipment from sun damage

❑ Remove minor scale build-up on pools, spa, rails, tiles. Use 3M pad or media blast

❑ Service the 5 Pentair ETI heaters on a regular basis. Get Pentair training.

❑ Clean pool deck with TSP and pressure washer to remove staining.

❑ Ensure pool drains are VGB compliant. Must have labels. Replace every 3 to 5 years.

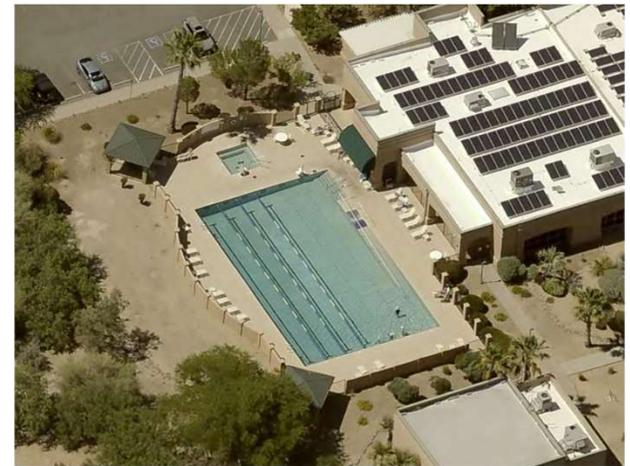
Las Campanas

❑ **Pool built 1997, 50x82 ft, 137,500 gallons**

- ❑ Replace two chemical controllers to digital systems for accuracy
- ❑ Check pool and spa lights for proper securement
- ❑ U-3 style skimmers: repair weirs and install correct baskets

- ❑ Replace manual fill valve on pool. Broken handle. May require cutting concrete deck.
- ❑ Add additional TR-140 pool filter. Replace spa filter with new TR-140 for correct flow.

- ❑ Replace three 3hp single-speed pool pumps with two new 5hp variable-speed pumps.
- ❑ Replace single-speed spa and jet pumps with two 3hp Intelliflow pumps

- ❑ Install correct D2 power vents on four Raypak gas heaters to prevent sooting.
- ❑ Replace backwash valves that are less restrictive. Re-plumb equipment room for efficiency.

- ❑ Install Flo-viz meters and vacuum gauges on suction side of pumps per code. Replumb equipment room.
- ❑ Install Emergency Shut-off (ESO) switch by pool and spa to meet current code. Install ESO by boilers.

- ❑ Install Pentair I10D automated control system with an Intellichem control system

- ❑ Install new chemical placards per code. Replace life rings with new 24" size.
- ❑ Remove minor scale build-up on pools, spa, rails, tiles. Use 3M pad or media blast
- ❑ Clean pool deck with TSP and pressure washer to remove staining. Repaint with acrylic when needed.
- ❑ Balance chemicals to reduce copper staining from heaters
- ❑ Replace pump seals. Showing signs of leaking.
- ❑ Ensure pool drains are VGB compliant. Must have labels. Replace every 3 to 5 years.

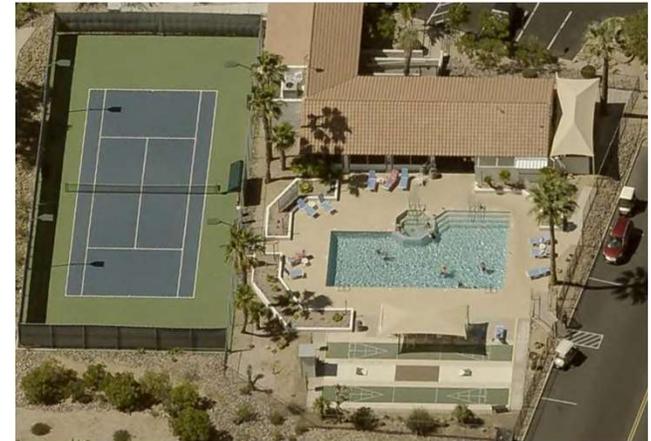
Madera Vista

Pool built 1983, 25x50 ft, 35,966 gallons

- Replace two chemical controllers to digital systems for accuracy
- Replace one 3hp Whisperflow spa pump with 3hp Intelliflow variable-speed pump
- Connect the spa filter/jet pump to the Intellicenter for proper flow and electric cost savings
- Replace backwash valves that are less restrictive. Re-plumb equipment room for efficiency.
- Install Flo-viz meters and vacuum gauges on suction side of pumps per code.
- Install Emergency Shut-off (ESO) switch by pool and spa to meet current code
- Install Pentair I10D automated control system with an Intellichem control system

- Install new chemical placards per code. Replace life rings with new 24" size.
- Remove minor scale build-up on pools, spa, rails, tiles. Use 3M pad or media blast
- Clean pool deck with TSP and pressure washer to remove staining. Repaint with acrylic.
- Balance chemicals to reduce copper staining from heaters
- Ensure pool drains are VGB compliant. Must have labels. Replace every 3 to 5 years.
- Get Pentair heaters serviced bi-annually by official service tech

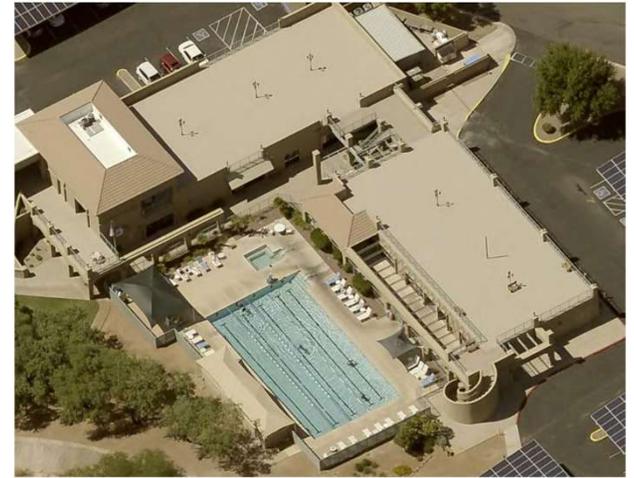
Santa Rita Springs

❑ **Pool built 1996, 38x75 ft, 84,588 gallons**

- ❑ Replace two chemical controllers to digital systems for accuracy
- ❑ Install an ADA lift for spa. Pool has one.
- ❑ Add additional TR-140 pool filter. Spa filter is okay.
- ❑ Replace two 3hp single-speed pool pumps with three 3hp variable-speed or two 5hp VS pumps
- ❑ Replumb piping for proper flow when changing out pumps and filters
- ❑ Replace single-speed 3hp spa pump (leaking seal) with one new 3hp Intelliflow pump
- ❑ Install correct D2 power vents on four Raypak gas heaters to prevent sooting.
- ❑ Replace backwash valves that are less restrictive. Re-plumb equipment room for efficiency.
- ❑ Install Flo-viz meters and vacuum gauges on suction side of pumps per code.
- ❑ Install Emergency Shut-off (ESO) switch by pool and spa to meet current code. Install ESO by boilers.
- ❑ Install Pentair I10D automated control system with an Intellichem control system

- ❑ Install new chemical placards per code. Replace life rings with new 24" size.
- ❑ Remove minor scale build-up on pools, spa, rails, tiles. Use 3M pad or media blast
- ❑ Clean pool deck with TSP and pressure washer to remove staining. Repaint with acrylic.
- ❑ Balance chemicals to reduce copper staining from heaters
- ❑ Replace pump seals. Showing signs of leaking.
- ❑ Ensure pool drains are VGB compliant. Must have labels. Replace every 3 to 5 years.

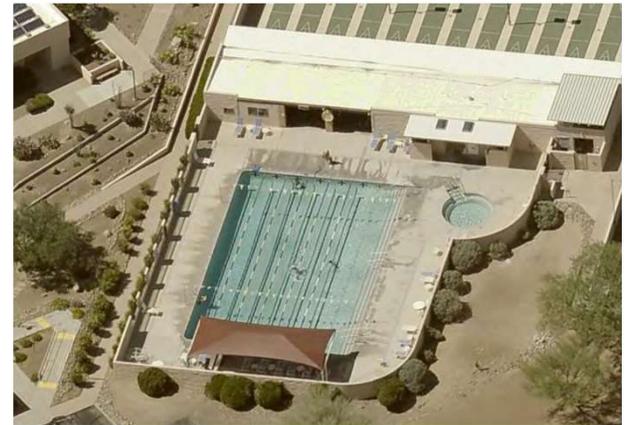
West Center

Pool built 1980, 50x75 ft, 114,635 gallons

- Replace two chemical controllers digital systems for accuracy
- Replace and reattach missing deck drain sections that are broken
- Check light in spa for proper connection

- Replace three TR-100 pool filters with four TR-140 filters to meet flow rates.
- Replace one TR-100 spa filter with two TR-100 filters with high-flow backwash system

- Replace two 3hp single-speed pool pumps with three 3hp variable-speed or two 5hp VS pumps
- Replumb piping for proper flow when changing out pumps and filters

- Replace single-speed 3hp spa pump (leaking seal) with one new 5hp Intelliflow variable-speed pump
- Install correct D2 power vents on four Raypak gas heaters to prevent sooting.

- Replace backwash valves that are less restrictive. Re-plumb equipment room for efficiency.
- Install Flo-viz meters and vacuum gauges on suction side of pumps per code.

- Install Emergency Shut-off (ESO) switch by pool and spa to meet current code. Install ESO by boilers.
- Install Pentair I10D automated control system with an Intellichem control system

- Install new chemical placards per code. Replace life rings with new 24" size.
- Remove minor scale build-up on pools, spa, rails, tiles. Use 3M pad or media blast
- Replace or repair degrading sections of concrete deck
- Clean pool deck with TSP and pressure washer to remove staining. Repaint with acrylic.
- Balance chemicals to reduce copper staining from heaters
- Clean out spa jets. Not all are working properly
- Replace pump seals. Showing signs of leaking.
- Ensure pool drains are VGB compliant. Must have labels. Replace every 3 to 5 years.
