## Reserve Study Transmittal Letter

**Re: Green Valley Recreation Inc; Full Study**

**RESERVE STUDY**

**Green Valley Recreation Inc**

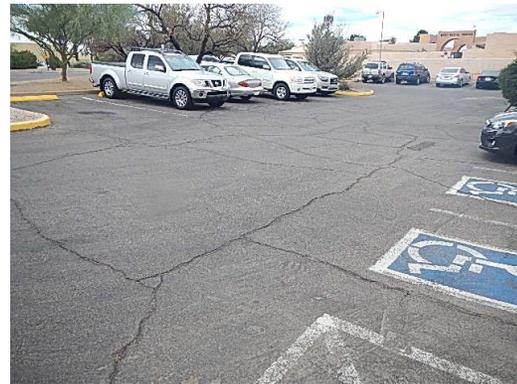
14,965 sq ft- south parking lot and maintenance yard  
 12,797 sq ft- north parking lot

300 - Asphalt: Overlay w/ Interlayer	Useful Life 25	Remaining Life 6	
14,965 Sq. Ft. South Parking & Maintenance	Quantity 14,965	Unit of Measure Square Feet	
	Cost /SqFt \$1.60	Total Cost/Study \$23,944	
	% Included 100.00%	Future Cost \$27,768	
Summary	Replacement Year 2022

This is to apply a paving fabric interlayer to the existing asphalt surface and overlay with a minimum of 1.5" of new hot mix asphalt. Generally this includes edge grinding and utility box extensions.

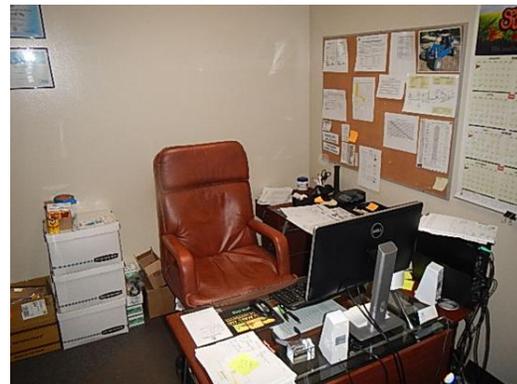
This is to replace computers, printers, scanners and networking equipment as needed.

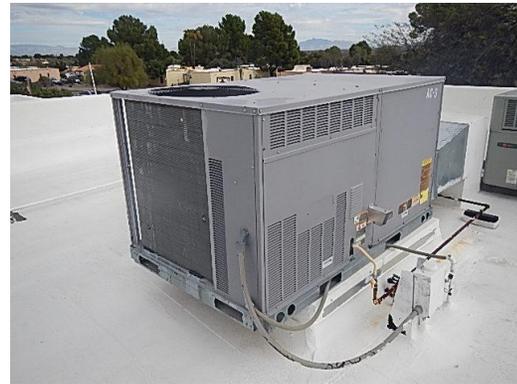
- Unit 1- Admin (S)- Carrier- 5T
- Unit 2- Admin (S)- Carrier- 5T
- Unit 3- Admin (Center)- Carrier- 5T

280 - HVAC	Useful Life 15	Remaining Life 1
Rooftop Carrier Unit- 2002	Quantity 1	Unit of Measure Items
	Cost /Itm \$5,000	
	% Included 100.00%	Total Cost/Study \$5,000
Summary	Replacement Year 2017	Future Cost \$5,125

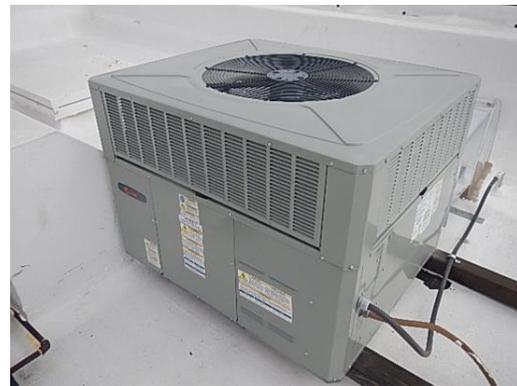
Unit 7- IT Room- Trane- 1.5T  
 Unit 9A & 9B- IT Server Room- Gree

376 - HVAC	Useful Life 15	Remaining Life 1
Bard Unit- 2002	Quantity 1	Unit of Measure Items
	Cost /Itm \$5,800	
	% Included 100.00%	Total Cost/Study \$5,800
Summary	Replacement Year 2017	Future Cost \$5,945

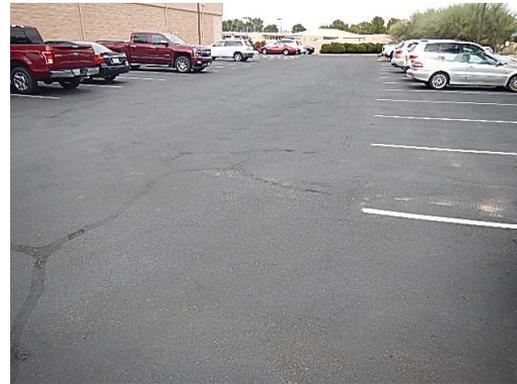
7,155 sq ft- loading dock driveway  
 23,812 sq ft- north parking lot  
 12,576 sq ft- south parking lot

112 - Asphalt: Sealing	Useful Life 5	Remaining Life 1	
75,321 Sq. Ft. West Parking Lot	Quantity 75,321	Unit of Measure Square Feet	
	Cost /SqFt \$0.200		
	% Included 100.00%	Total Cost/Study \$15,064	
Summary	Replacement Year 2017	Future Cost \$15,441

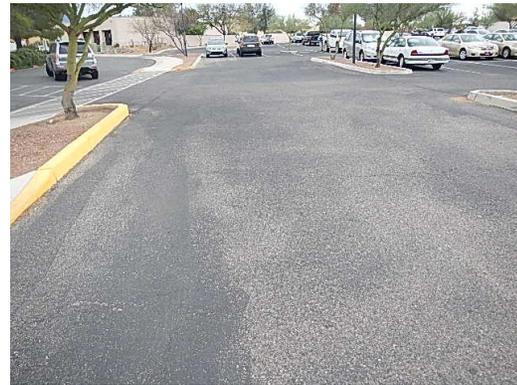
In 2016, the west parking lot is in need of crack fill.

306 - Asphalt: Overlay w/ Interlayer	Useful Life 25	Remaining Life 8	
43,543 Sq. Ft. Drives, North & South Parking	Quantity 43,543	Unit of Measure Square Feet	
	Cost /SqFt \$1.60	Total Cost/Study \$69,669	
	% Included 100.00%	Future Cost \$84,885	
Summary	Replacement Year 2024

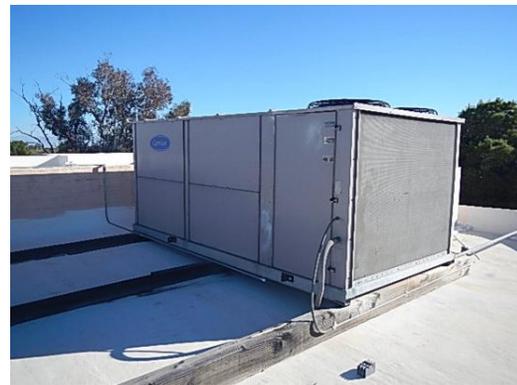
- Unit 1- Auditorium (W)- Carrier- 20T
- Unit 2- Auditorium (E)- Carrier 20T

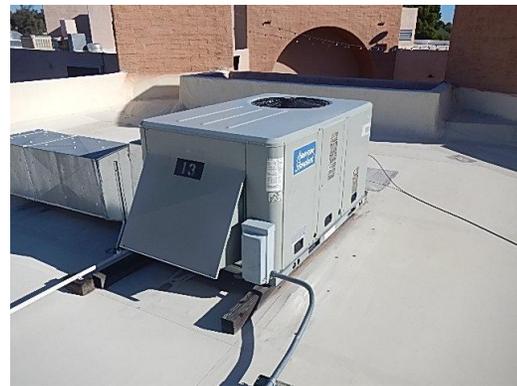
- Unit 5- Lobby (W)- Carrier- 10T
- Unit 12- Billiard Room- American Standard- 4T
- Unit 13- La Tienda- American Standard- 3.5T

380 - HVAC	Useful Life 15	Remaining Life 9	
Rooftop Carrier Unit- 2010	Quantity 1	Unit of Measure	Items
	Cost /Itm \$12,000		
	% Included 100.00%	Total Cost/Study	\$12,000
Summary	Replacement Year 2025	Future Cost	\$14,986

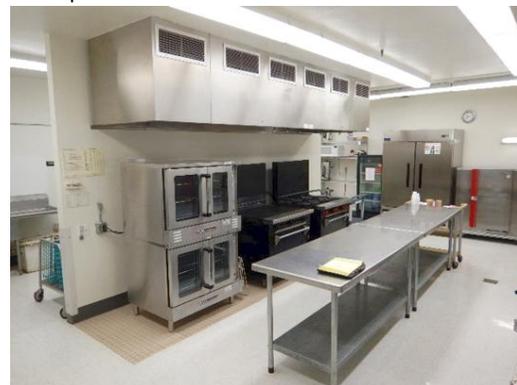
2016- Southbend CGS/28SC dbl stack convection oven replaced prior oven.

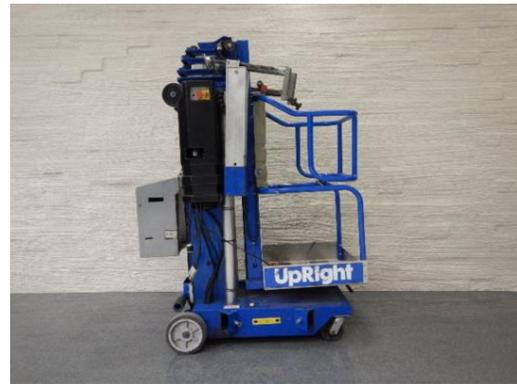
- UpRight manlift, MN 068001-001M, SN 20642
- JLG manlift, MN SCR121097B1, SN 11292160
- Genie Industries 15' easy up lift, MN EU-15, SN 2785-354

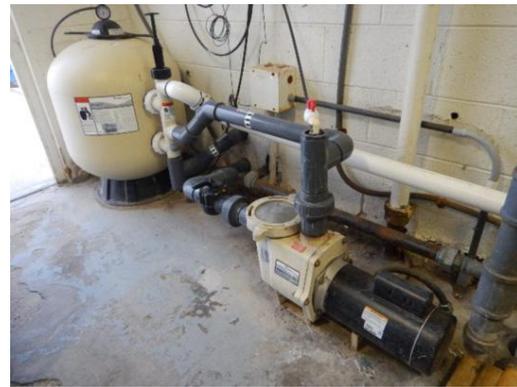
- 3- Pentair Triton II Commercial filters
- 2- Pentair Intelliflo Variable Speed pumps
- 1- additional spa pumps
- 3- Raypak Professional heaters (2- pool, 1- spa)
- 2- Aquasol chemical control systems
- Assorted- pipes, fittings, controls, lights, etc
- Carbon dioxide tank is not provided for within reserves.

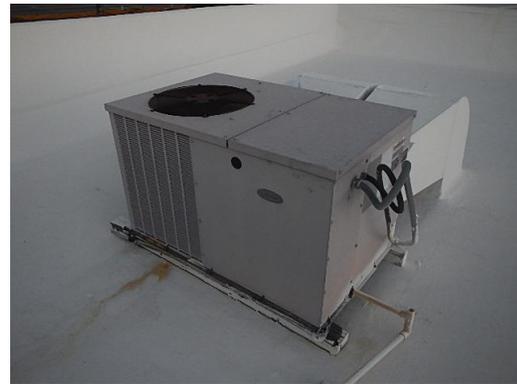
- Unit 2- Art Room- Carrier- 3.5T
- Unit 6- Locker Room- Carrier- 4T
- Unit 7- Office- Carrier- 4T
- Unit 11- Fitness- Carrier- 5T

324 - HVAC	Useful Life 15	Remaining Life 8
Rooftop Carrier Unit- 2009	Quantity 1	Unit of Measure Items
	Cost /Itm \$12,000	
	% Included 100.00%	Total Cost/Study \$12,000
Summary	Replacement Year 2024	Future Cost \$14,621

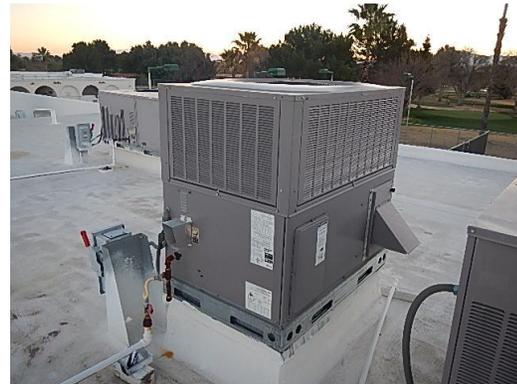
- Unit 5- Lobby- Carrier- 3T
- Unit 12- Fitness- Carrier- 5T
- Unit 13- Billiard Room- Carrier- 4T
- Unit 14- Lapidary Annex- Carrier- 4T
- Unit 15- Lapidary- Carrier- 4T

424 - HVAC	Useful Life 15	Remaining Life 1
2 Rooftop Carrier Units- 2002	Quantity 2	Unit of Measure Items
	Cost /Itm \$4,000	
	% Included 100.00%	Total Cost/Study \$8,000
Summary	Replacement Year 2017	Future Cost \$8,200

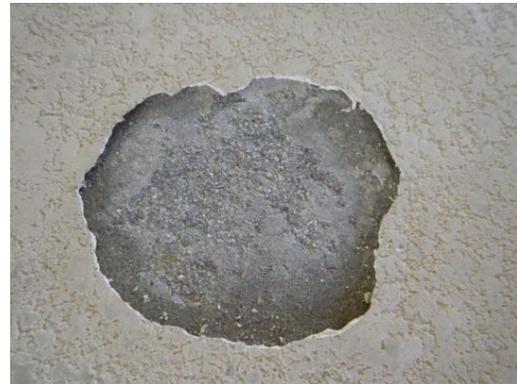
Typical failure.
